BOMB CRATER REPAIR TECHNIQUES FOR PERMANENT AIRFIELDS

TECHNICAL REPORT GL-81-12

Report 3
SERIES 4 TESTS

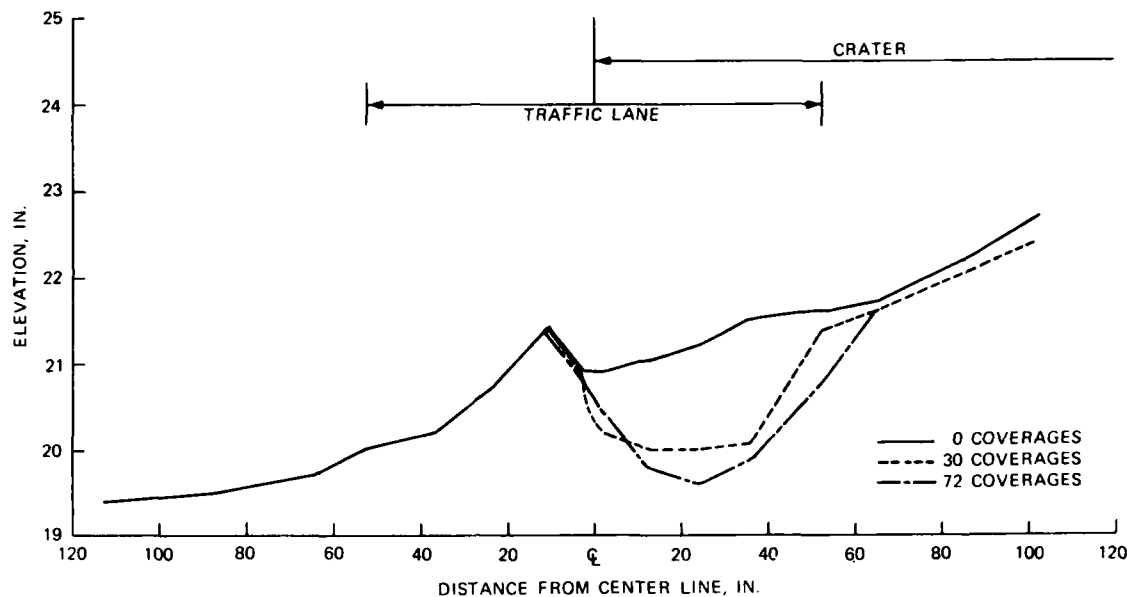
Figure 10. Cross-section data of the rutted area, crater 3, lane 1, after F-4 traffic

gravel in the rutted area. This material became unstable and shifted under the wheel. Photo 35 shows the surface condition after 550 passes or 72 coverages of the F-4. Figure 10 shows typical cross-section data of the rutted area. The loose material was removed from the rutted area and replaced with a well-graded crushed limestone and rolled 4 passes with the vibratory roller at 36-kip dynamic force. In repairing the rutted area it was found that the loose material was confined to the top 5 in., which was the last lift placed in the section. The stabilized sandy gravel under the rutted area was in excellent condition; this was the second lift placed in the repair. The rutted area was repaired to see if it was possible to patch a small area such as this with crushed limestone and continue traffic on craters 2 and 4. Photo 36 shows the traffic lane after 340 passes or 100 coverages of C-141 traffic, with no apparent damage. Note that the limestone repair is in the background. At 952 passes or 280 coverages a 1-in. rut had developed in the stabilized material at the edge of the patched area. This rut did not increase in depth as traffic continued. However, a 1-in. rut developed in the southwest corner and along the south edge of the crater repair after 1700 passes or 500 coverages. This rut increased in depth to 2 in. with the continuation of traffic to 3400 passes or 1000 coverages (Photo 37). Figure 11 shows cross-section data for the west end of the traffic lane.

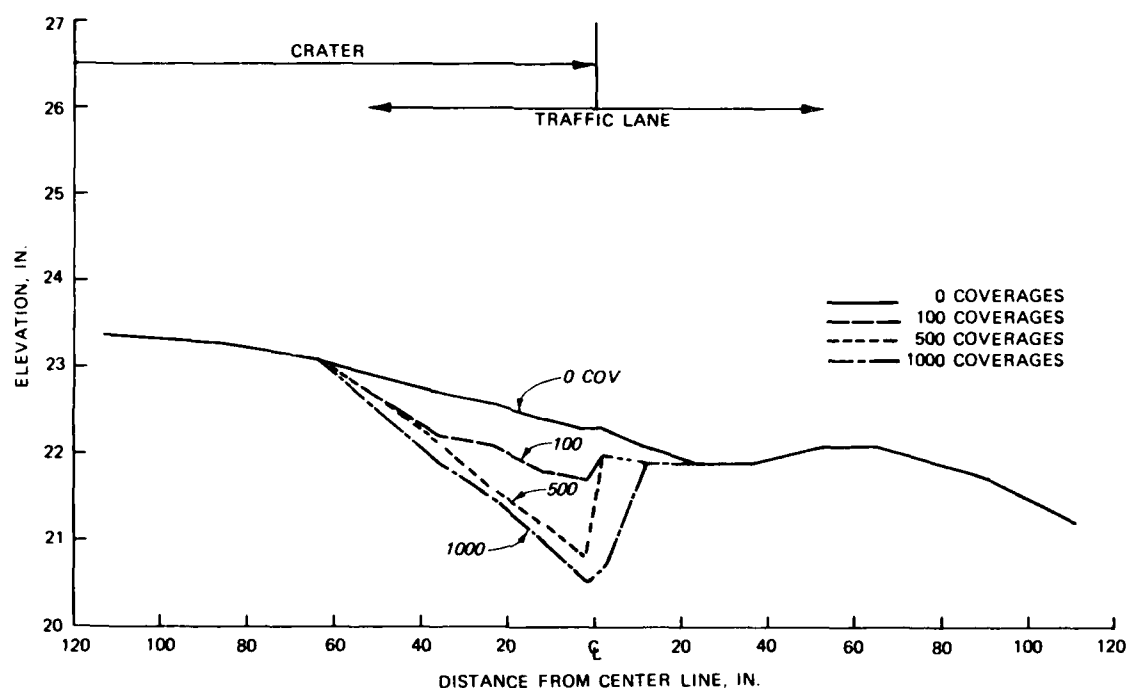
Figure 14. Cross-section data for crater 4, lane 2

of the loose grout measuring 1 in.³ (Photo 47). After 1020 passes or 300 coverages, the spalling along the edges of the crater had progressed 13 in. back into the crater repair and there was spalling on some of the cracks inside the traffic lane. From 340 passes or 100 coverages to 3400 passes or 1000 coverages there was no noticeable increase in the number of cracks, only the continuation of the spalling. Photo 48 shows the surface conditions after 3400 passes or 1000 coverages. As in lane 1 there was consolidation of about 2 in. of the repair materials under traffic (Figure 14).

- f. The consolidation of the crushed limestone in craters 4 and 5 showed that additional compaction, other than with a roller, is required along the edges on material placed below the surface of the crater repair. This could be accomplished with a gasoline-powered hand impactor compactor or vibratory plate compactor attached to a backhoe boom (Series 4, craters 4 and 5).
- g. The 18 in. of neat grout-large stone repair is recommended for the semipermanent crater repair where concrete transit mix trucks are not available.
- h. The asphalt caps are not recommended due to the difficulty in placement of correct temperatures and the question of availability of asphalt during wartime.

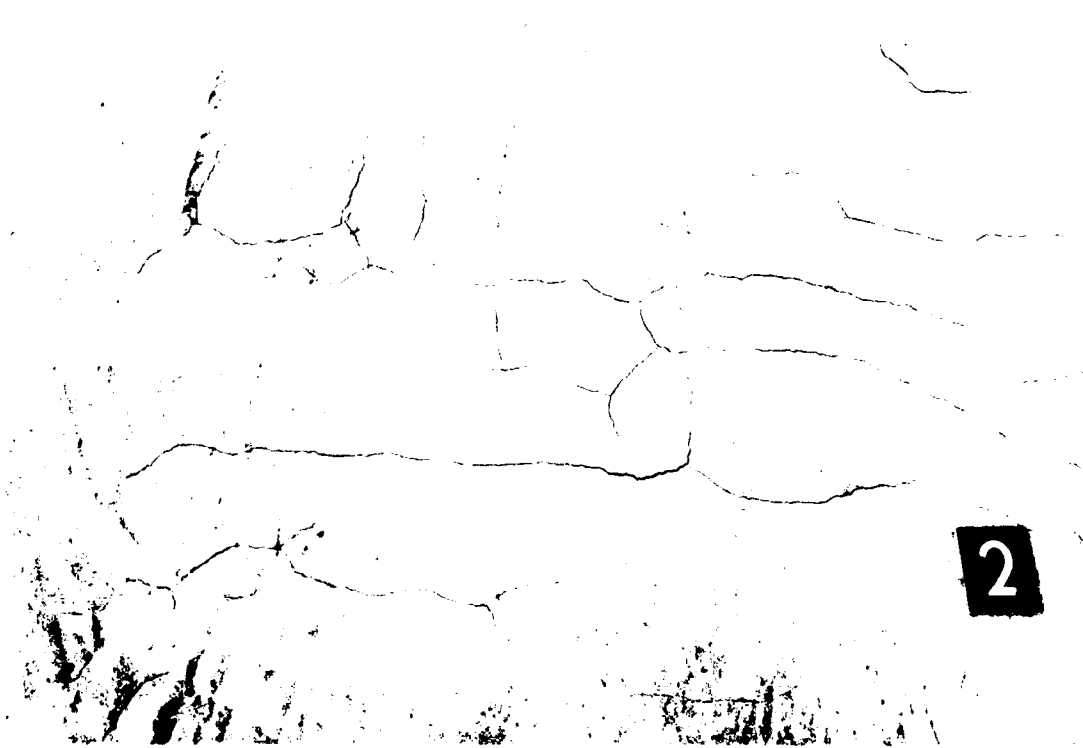
25. As in crater 1, shrinkage cracks developed in the crater repair in limited numbers, approximately 1 hr after placement. Photo 26 is a close-up of the most severe cracks.

Photo 26. Close-up of the shrinkage cracks in crater 2
